# Treated Wood in Aquatic Environments

A Specification and Environmental  
Guide to Selecting, Installing and  
Managing Wood Preservation Systems  
in Aquatic and Wetland Environments

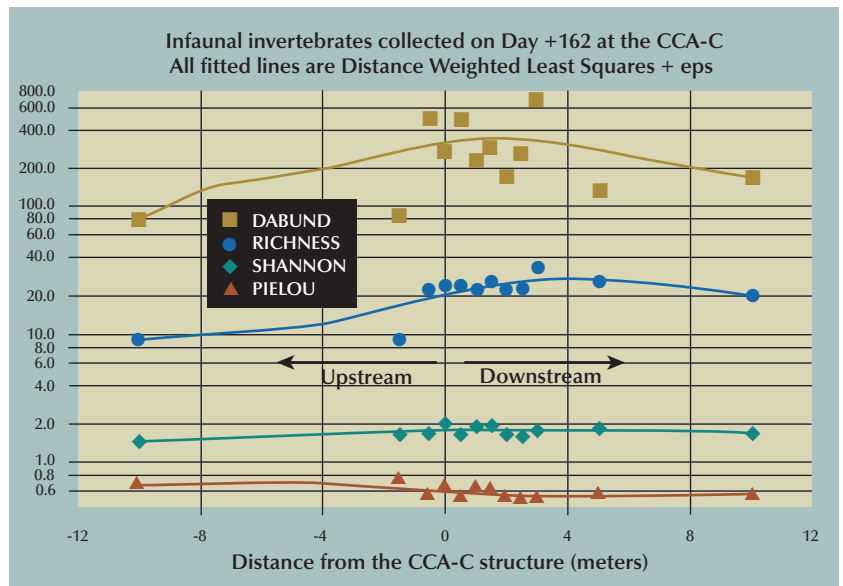
Figure 3 above describes the community of animals that live in the sediments (infauna) at the end of the study when sediment concentrations of all metals had reached their peak. Again, there is no indication that the CCA-C structure resulted in a compromise of these infauna, which are sessile (stationary) and had been exposed to the pressure treated wood structure for a year. The same results were obtained for the other two preservatives. It is impossible to prove a negative and therefore we cannot state that there could never be an adverse effect associated with these structures. *What we can say is that this worst case study did not reveal any adverse environmental effects and these results indicated that these preservatives can safely be used in sensitive wetland areas.*

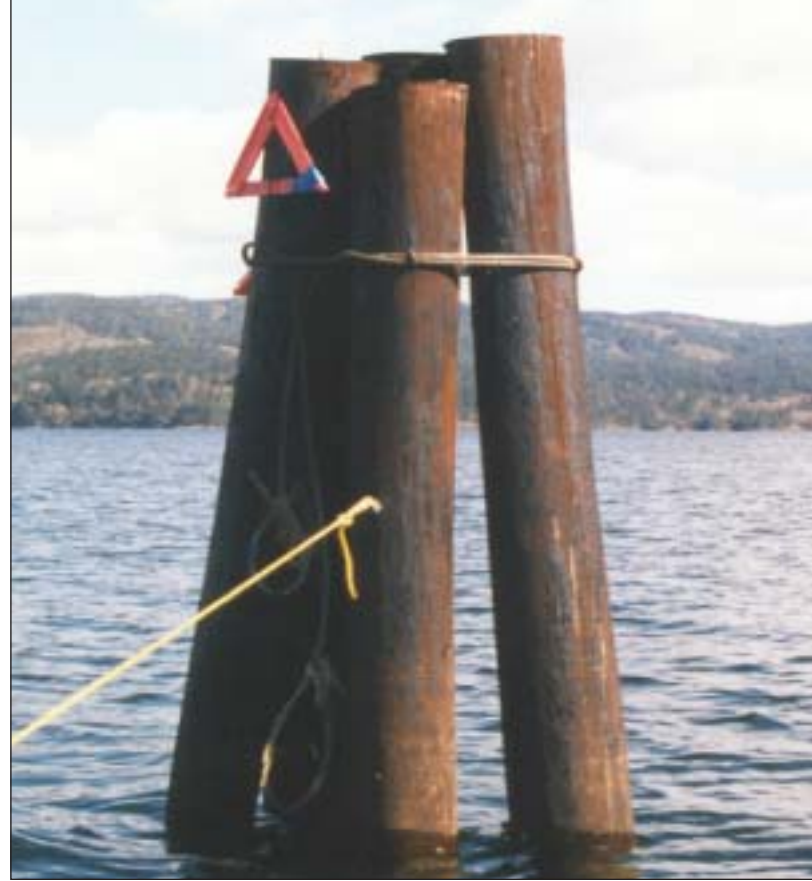
*New creosote-treated dolphin used to evaluate creosote in Sooke.*

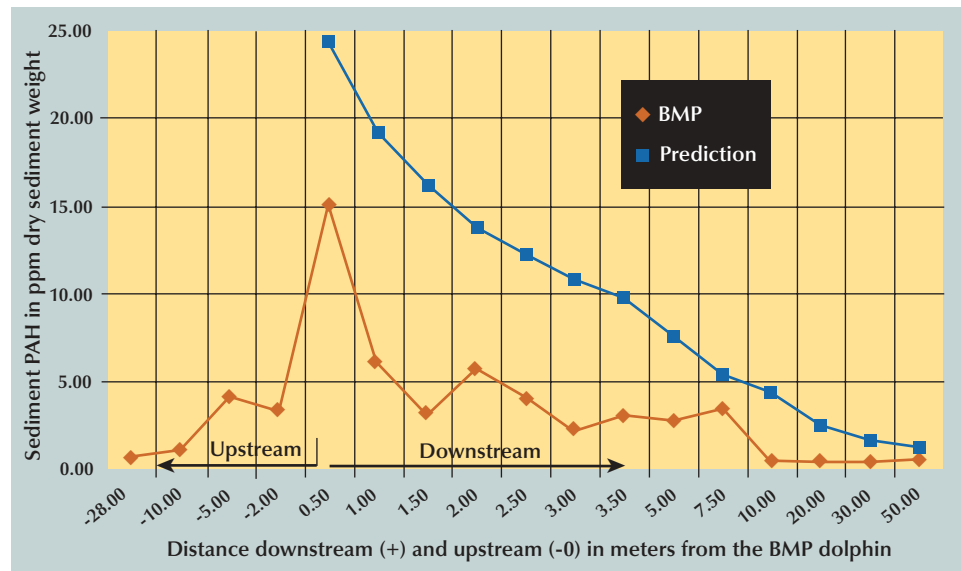
- Creosote did migrate from the piling and accumulate in sediments downcurrent from the piling. As shown in Figure 4 below, the actual accumulation of PAH in sediments (red line) was less than that predicted in the model (blue line). These sediment concentrations also peaked earlier and declined faster than predicted. These models have been field-verified repeatedly over the last six years. In every case, they have proven conservative from the environment's point of view – that is, predictions of PAH accumulation were higher than what was actually observed.

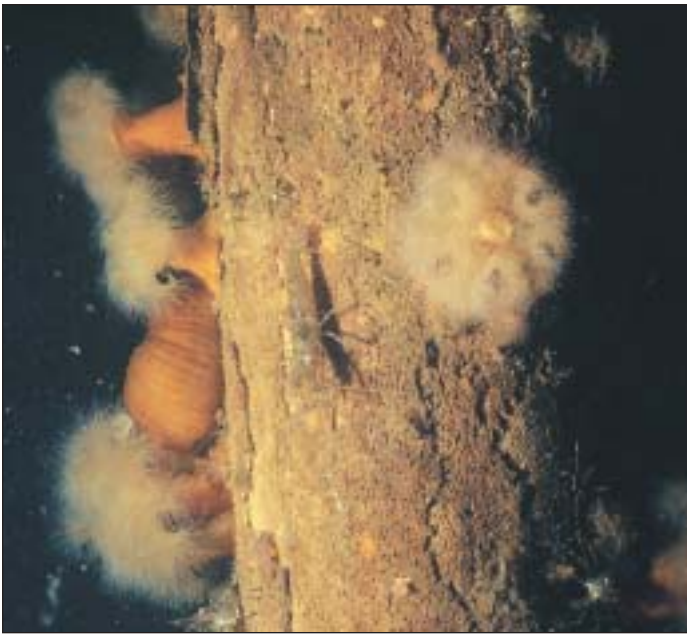
*The untreated piling were deteriorating and did not support a vibrant fouling community*

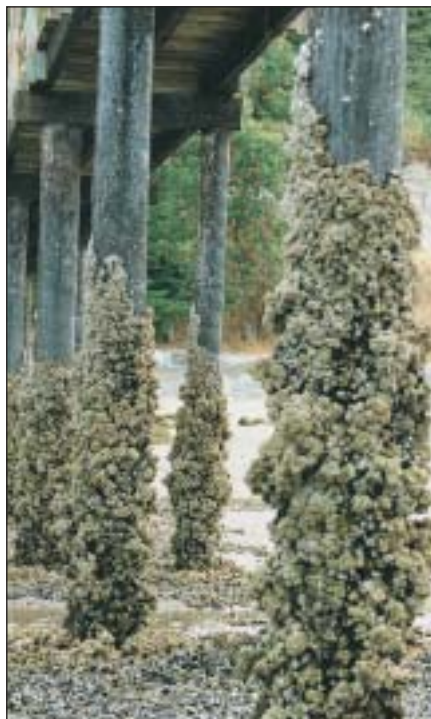
*The personal use pier shown here is constructed of creosote-treated piling with ACZA-treated walkways*

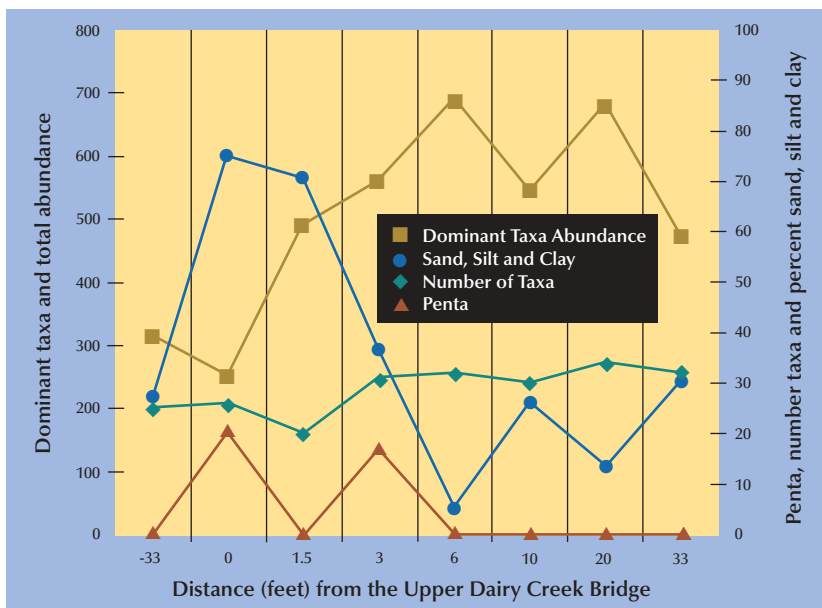
Figure 5

These two bridges were located over salmon-spawning rivers with sand-gravel and cobble substrates supporting a vibrant community of pollution-intolerant aquatic insects in the Orders Ephemeroptera (mayflies) and Trichoptera (caddis flies). The larvae of these Orders are generally associated with fast-moving oligotrophic streams and rivers. The biological response of this sensitive community is illustrated in the figure below. It describes sediment pentachlorophenol concentrations ( $\mu\text{g}/\text{kg}$ ) in red; the proportion fine-grained sediments (sand, silt and clay) in blue; biological response described by the number of species (green); and the abundance of invertebrates (brown).

Note that the number of species and the total abundance of invertebrates were much higher three feet downstream from the bridge's drip line where the proportion of fine sediments dropped from 70 to 80 percent to about 40 percent. Also note that invertebrate abundance peaked where the proportion of fines decreased to between five and 12 percent. There were as many species and as many animals downstream from the bridge as there were at the upstream control. And there was essentially no correspondence between invertebrate community and the small amount of pentachlorophenol observed under the bridge and at the station located three feet downstream. Amphipod (*Hyaella azteca*) bioassays also found no evidence of toxicity in sediments from either of these pentachlorophenol-treated bridges. The invertebrate community was far more influenced by the substrate type than by the bridge.

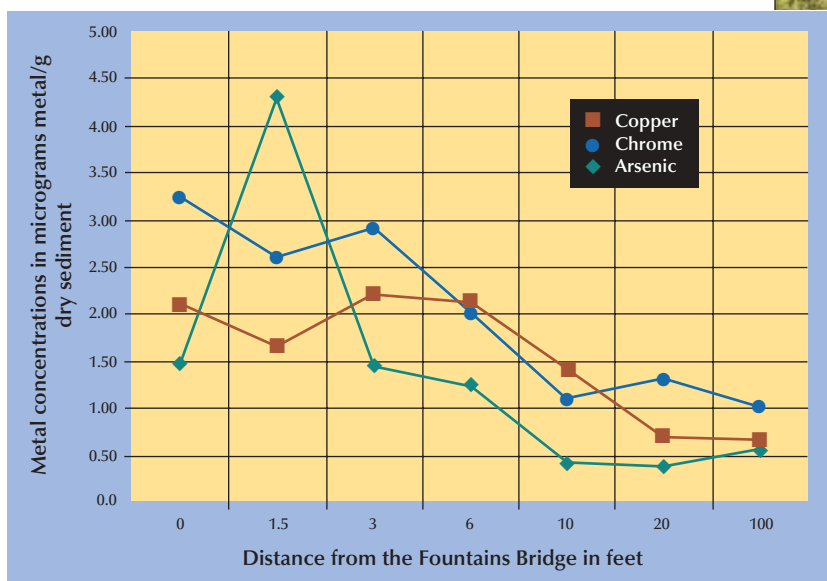
Figure 8

The second bridge examined in San Destin was the 8-year-old Fountain Bridge, which crossed a freshwater marsh. This older bridge was examined to evaluate the accumulation of metals in sediments around the bridge and their effect on infauna. Increases in dissolved metals were not observed in the vicinity of the bridge in this essentially stagnant body of water.

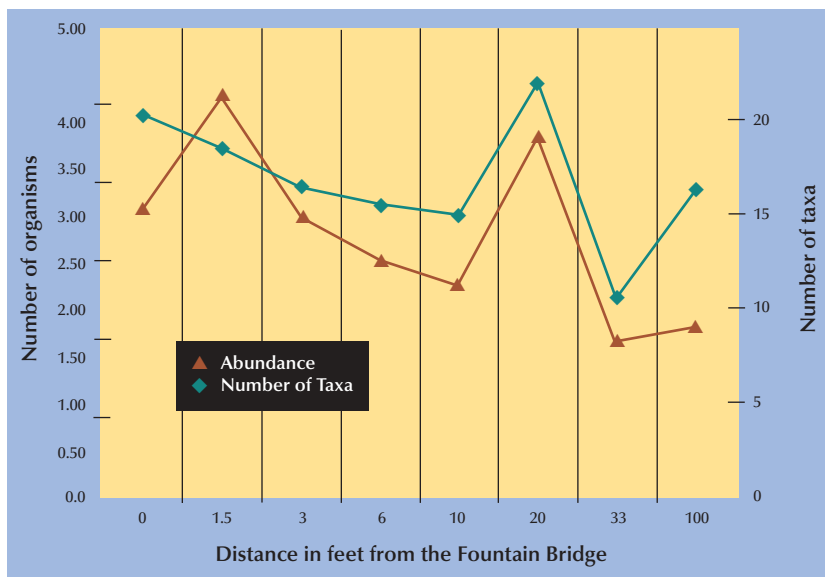
Figure 9 describes sediment concentrations of metals under and adjacent to the bridge. Sedimented metal concentrations were all very low ( $<4.25 \mu\text{g/g}$ ). However, the bridge has left a definite signature in the muddy substrate that extends to a distance of between six and ten feet from the piling. Having said that, the maximum observed concentration of each metal was less than background concentrations in most parts of North America. No biological effects whatsoever could be expected at these concentrations and, as seen in Figure 9, none were observed. The abundance and diversity of invertebrates was as high under and immediately adjacent to the bridge as they were further away.
