**Washington State Ferries Are Destroying Habitat
and Wasting Money in
Misplaced Effort to Restore Habitat Through
Creosote Removal Initiative**

Creosote Council II

**Stephen T. Smith
AquAeTer, Inc.
P. O. Box 1600
Helena, MT 59624**

February 2003

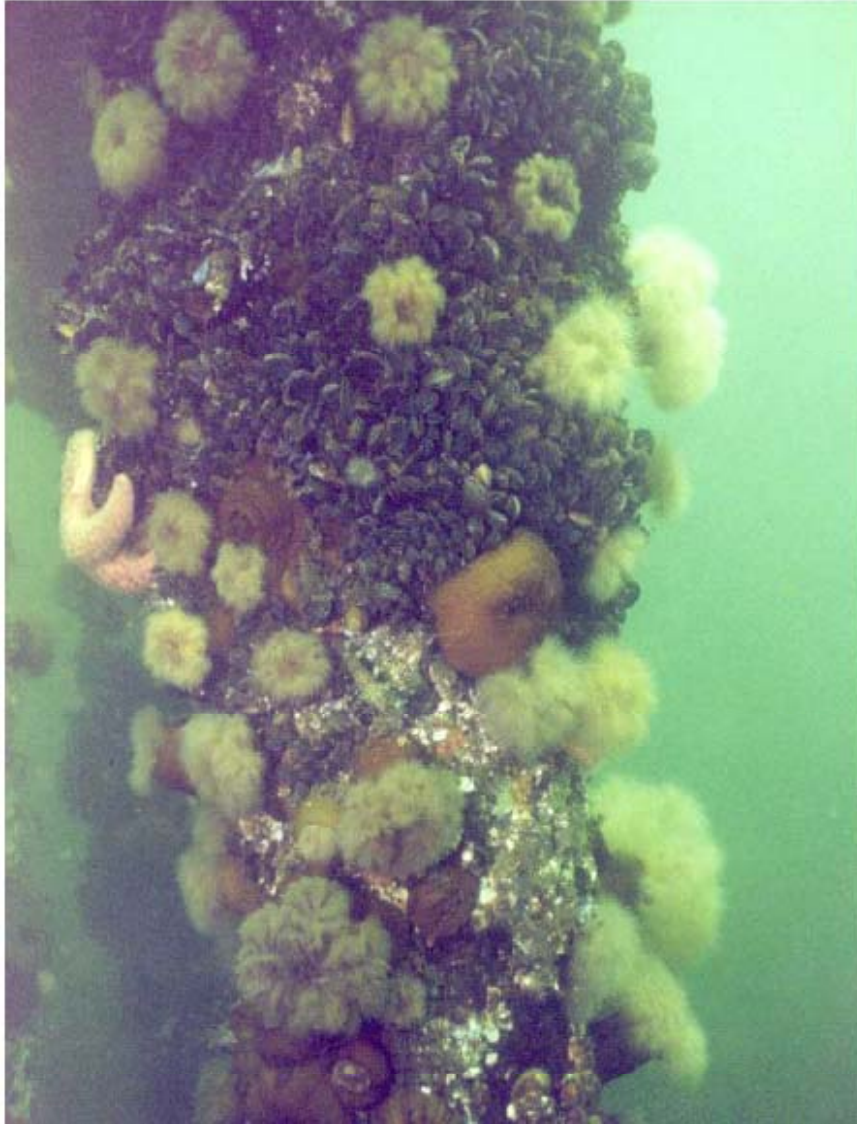
Proof of this statement is provided by the photograph on the following page of one piling addressed in this study. Note the prolific marine growth attached to the creosote treated piling after only four years in the water.

Sooke Basin Creosote Treated Piling
After 4 Years In Place

At the end of four years, the most significant environmental response to these structures was the establishment of a diverse and abundant epifaunal [surface attached] community on the piling and the attraction of large numbers of Dungeness crabs, starfish, finfish and other megafauna [larger animals] to what had become an artificial reef.

All of the pilings on Day 14 were relatively 'clean' with little or no evidence of new marine growth. By Day 180 [about 6 months], a light film of brown filamentous algae had developed on the BMP [creosote treated] piling. This film became progressively thicker near the water's surface. A marine community had started to establish itself on the pilings by Day 384 [about 1 year]. The amount of growth appeared to be slightly greater on the MC [untreated control] pilings than at the BMP site, particularly with respect to the number of mussels. By Day 1540 [about 4 years], a diverse and abundant biological community covered the entire length of the BMP pilings. This community included mussels, barnacles, numerous starfish (up to 15 to 20 individuals per piling in some cases), plumose sea anemones, calcareous

tube worms, hermit crabs, coonstripe shrimp, tunicates, marine snails, sea cucumbers, sponges, macroalgae and a host of other marine organisms. In contrast the untreated piling supported a much smaller community because the pilings were disintegrating.
