Treated Wood Aquatic Case History

**MARK O. HATFIELD MARINE SCIENCE CENTER
OREGON STATE UNIVERSITY**

Inspection Finds Creosote Treated Piling Sound After 28 Years Of Service.

PROJECT: OSU Research Vessel
Dock & Trestle Expansion
Newport, Oregon

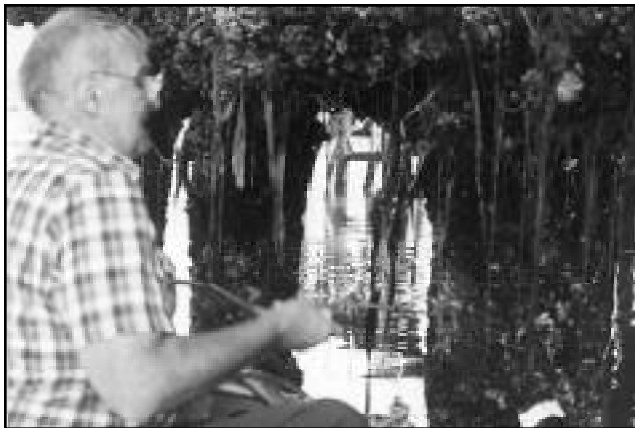
RESULTS: All cores had sapwood penetration of 100%; retention below the tide line was 21.38 PCF and 17.34 PCF above the tide line.

TPI inspectors pull test cores to check penetration and retention levels.

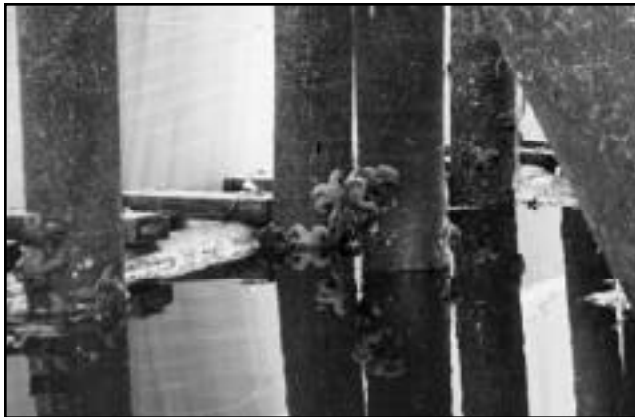
The piling inspected and bored appeared to be in excellent shape and continue to support the dock and trestle platforms. Out of all 119 piling that supported this project, only one needed replacing. That pile was damaged by mechanical abrasion and not product failure.

The piling were heavily encrusted with starfish, sea anemones, mussels and other varieties of sea life.
